RE: Marion Cross School, Wastewater Disposal System – Hydrogeologic Evaluation
of a Failed Wastewater Disposal System and the Overall Norwich Town Green

EXISTING CONDITIONS WASTEWATER PLAN
MARION CROSS SCHOOL
 22 CHURCH STREET – NORWICH, VERMONT

Marion Cross School Hydrogeologic Analysis

Hydraulic Conductivity Test Results
Marion Cross School
Wastewater Disposal Area Hydrogeological Analysis
July 30, 2019
By Stephen Revell, CPG Senior Hydrogeologist

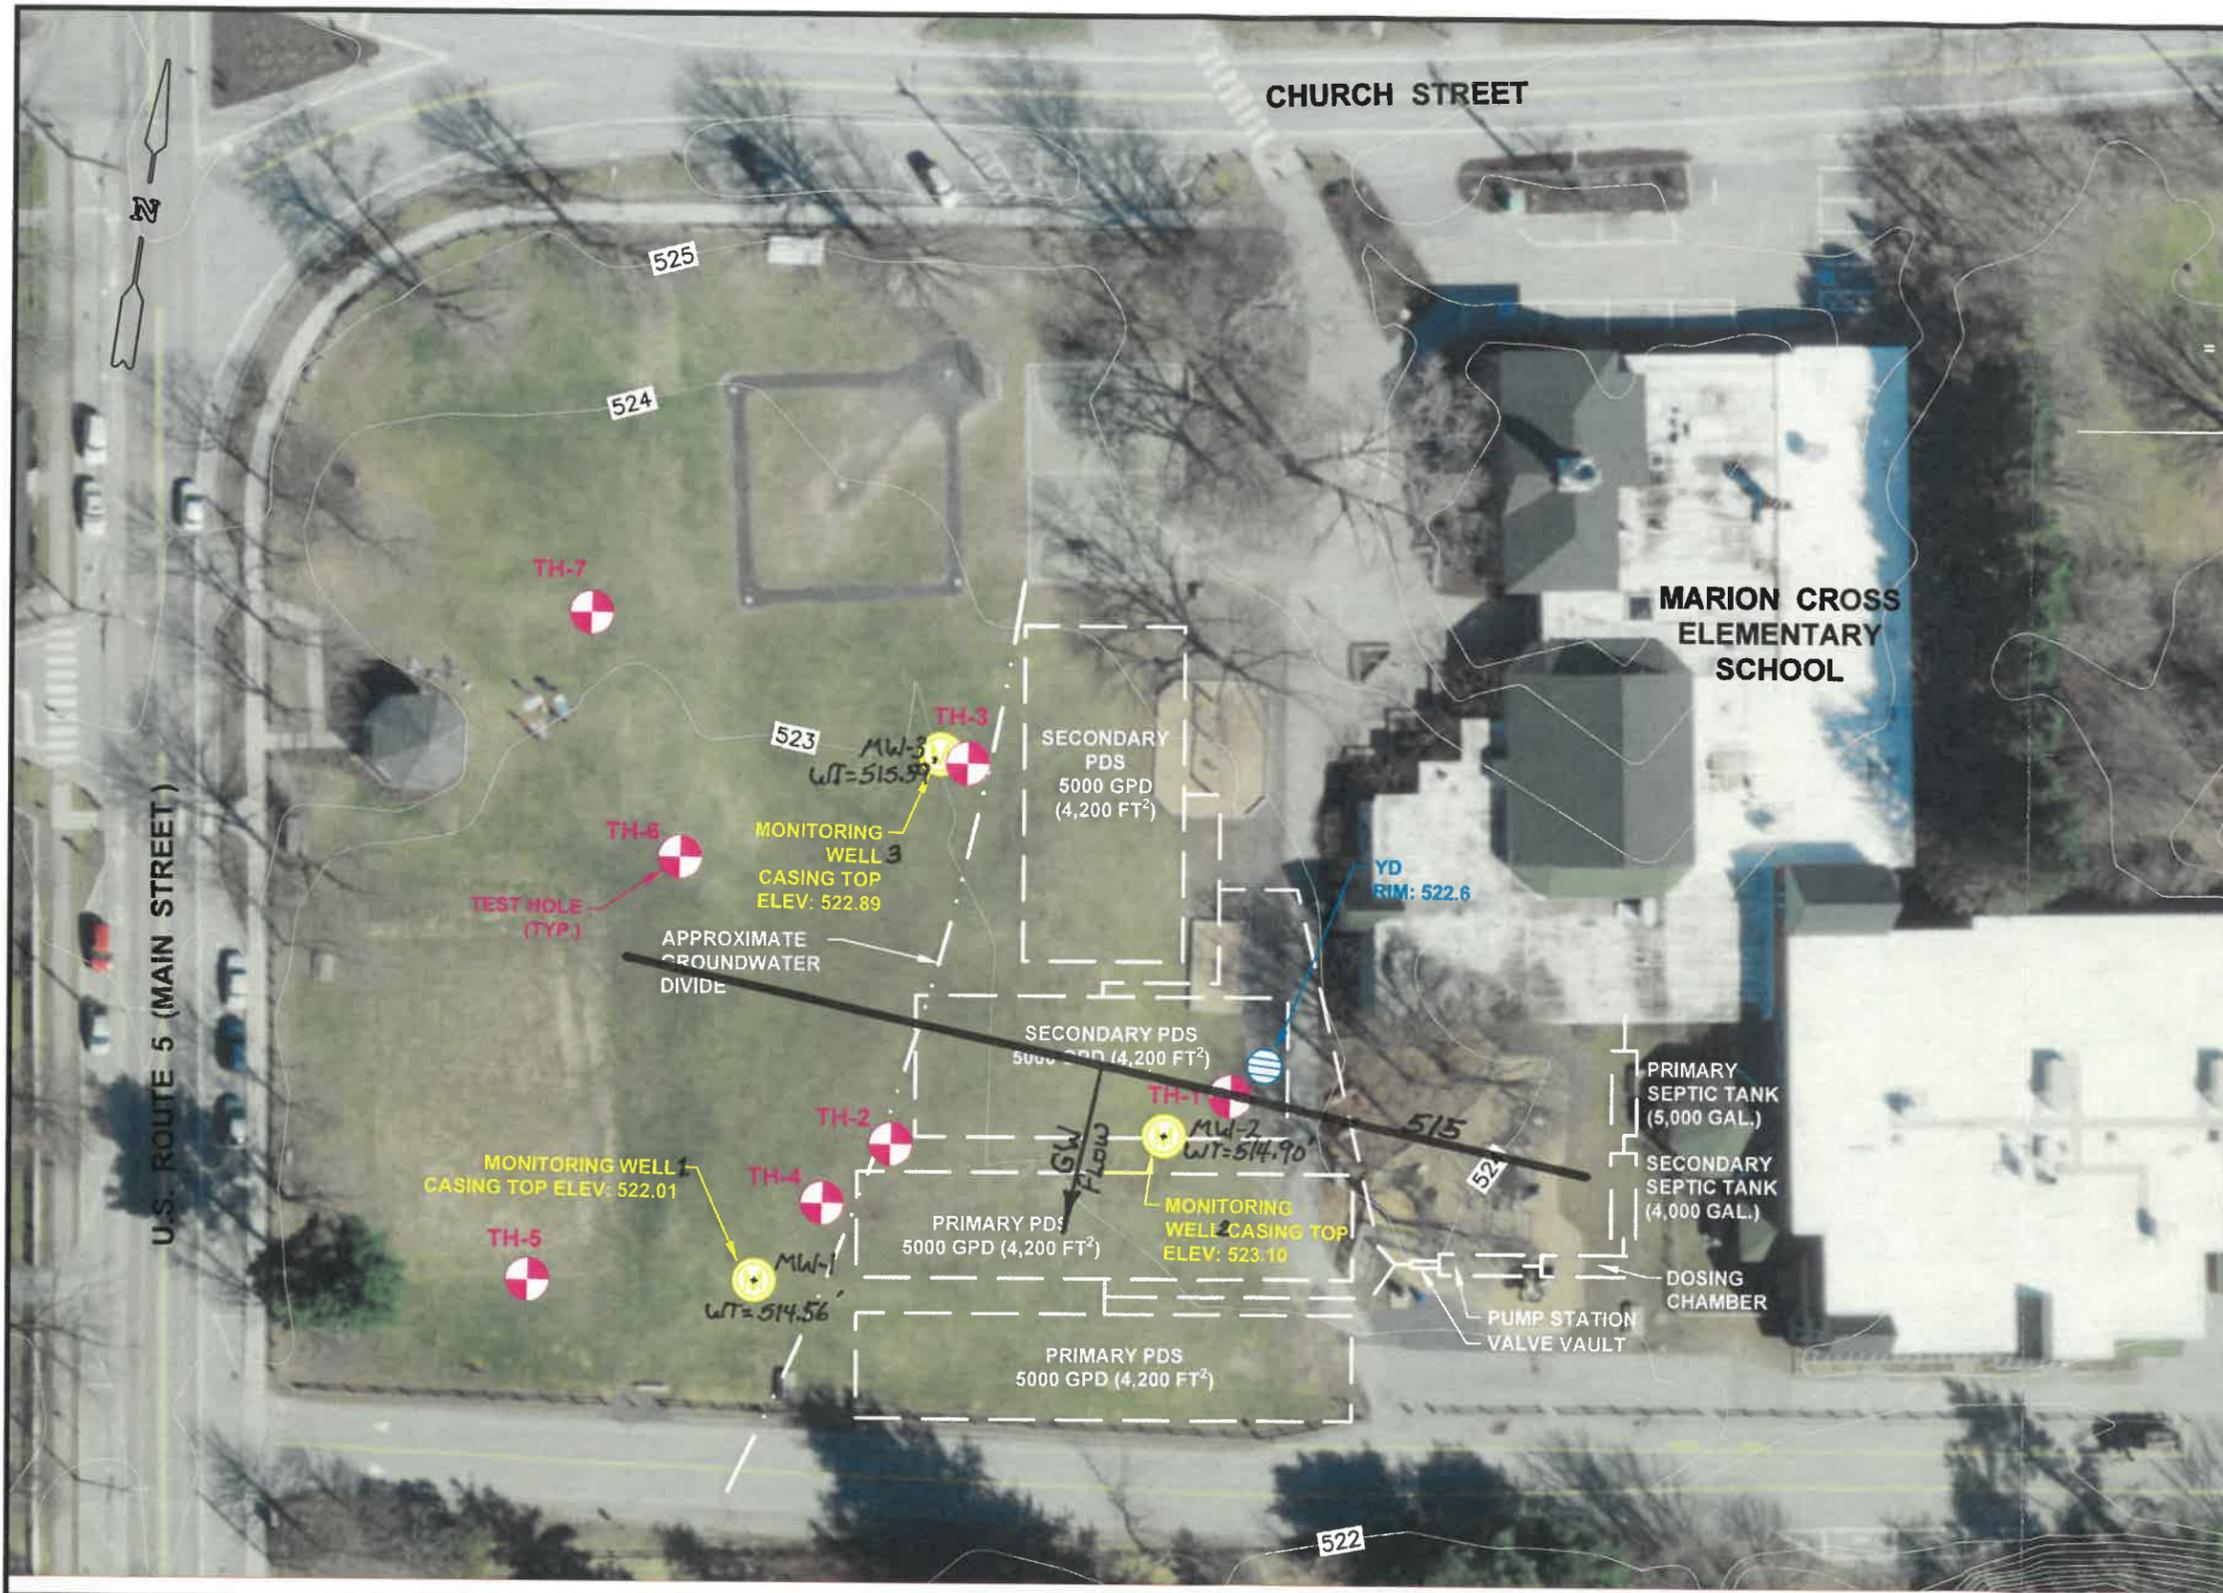
FIGURE
1

A series of seven (7) test holes shown on Figure 1 were excavated and evaluated by Tim McCormick of PC and Stephen Revell, CPG of LAG on June 13, 2019 with Terry Shearer, State Regional Engineer in attendance. Formal descriptions were compiled by Tim McCormick, Soil Scientist which are presented in Attachment C. The test hole locations are shown on the attached Figure 1 – Existing Conditions Wastewater Plan prepared by PC. Four test holes (TH-1 through TH-4) were placed adjacent to each of the 4- 4200 sq. ft. disposal fields to define soil conditions and evidence of failure or proper function. Three additional test pits were excavated and evaluated on the western half of the Green (TH-5, 6 and 7) to define native soil conditions and water table limitations beneath the overall Green.

To define the soil characteristics at depth, 3 borings/ monitoring wells shown on Figure 1 were installed and evaluated to a depth of 12 to 15', directly adjacent to test holes 1, 3 and 4. The boring/ monitoring well descriptions are included in Attachment C. They indicated the presence of fine to coarse sands with minor gravel to a depth of 11 to 12', underlain by fine sand to silt. They were found to be saturated at a depth of 6 to 7". The boring/monitoring well descriptions indicate the presence of permeable well drained sands which preliminarily appeared capable of handling the current wastewater flows (+/- 5000 gpd) from MCS. The boring/ monitoring wells were also placed to define the water table and direction of groundwater flow in the area of the 4 disposal areas, as well as to allow the hydraulic conductivity/ permeability of the native sand deposits to be defined.

EXISTING SYSTEM
 500 STUDENTS WITH KITCHEN=10,000 GPD
 10,000 GPD
 1.2 GAL./FT² 8,333 FT²
 DUAL ALTERNATING SYSTEMS
 4-4,200 FT² BEDS

Saturated hydraulic conductivity tests were conducted on July 30, 2019 in the 3 monitoring wells and analyzed using Hvorslev's Method. Prior to the testing, the depth to water table was defined between 7.3' and 8.2' below ground surface. Utilizing the monitoring well elevations shown on the Figure 1 Existing

Conditions Wastewater Plan, groundwater elevations were calculated. As shown, they are 514.56'(MW-1), 514.90'(MW-2) and 515.59'(MW-3). A single groundwater contour (515') is shown which describes general groundwater flow to the south – southeast at a low (not flat) groundwater gradient of 0.0068 feet/feet which discharges into one or more tributaries of the Connecticut River. Depending on groundwater conditions at different times of the year, as well as cold weather related perturbations, I believe that flow components could be radial to the west, southwest, south and southeast. The results of the hydraulic conductivity analysis are contained in Attachment D. Three tests were conducted with hydraulic conductivities ranging from 40.48 ft./day to 40.94 ft./day to 42.70 ft./day. They are somewhat higher than the results generated by WHN. The average value is 41.37 feet/day which was used in the Site Specific Effluent Mounding Analysis utilizing Darcy's Law. This is an overall effects analysis which relates to all 4 disposal areas operating simultaneously. The results of this analysis indicate that a 8.48' effluent mound would develop beneath the disposal area in response to a maximum potential daily flow of 5000 gpd. It is important to note that the way the current system was operated through December 2019 with very limited alternation of the disposal areas, the mounding could be higher. As Attachment D shows, the Darcy's Law analysis was also conducted with literature values of 50 feet/day and 100 feet/day because 41.37 feet/day did not seem high enough for the underlying sands. The results indicate an effluent mound 7' and 3.5' will form.

The transducers were installed in monitoring wells MW-1 and MW-3 (shown on Figure 1) located on the west side of the overall disposal area on March 9, 2020 during what looked to be the meltdown of the snow and ice conditions on the surface of the Green and probably the frozen soil sides of the box. During the first week of monitoring, the school was in operation but after that the school was shut down for the mid-winter break and then was closed due to Covid-19. The school has remained closed to date. Because the school was shutdown, the transducers were removed on March 31, 2020 to evaluate water table impacts during the one week of school operation.

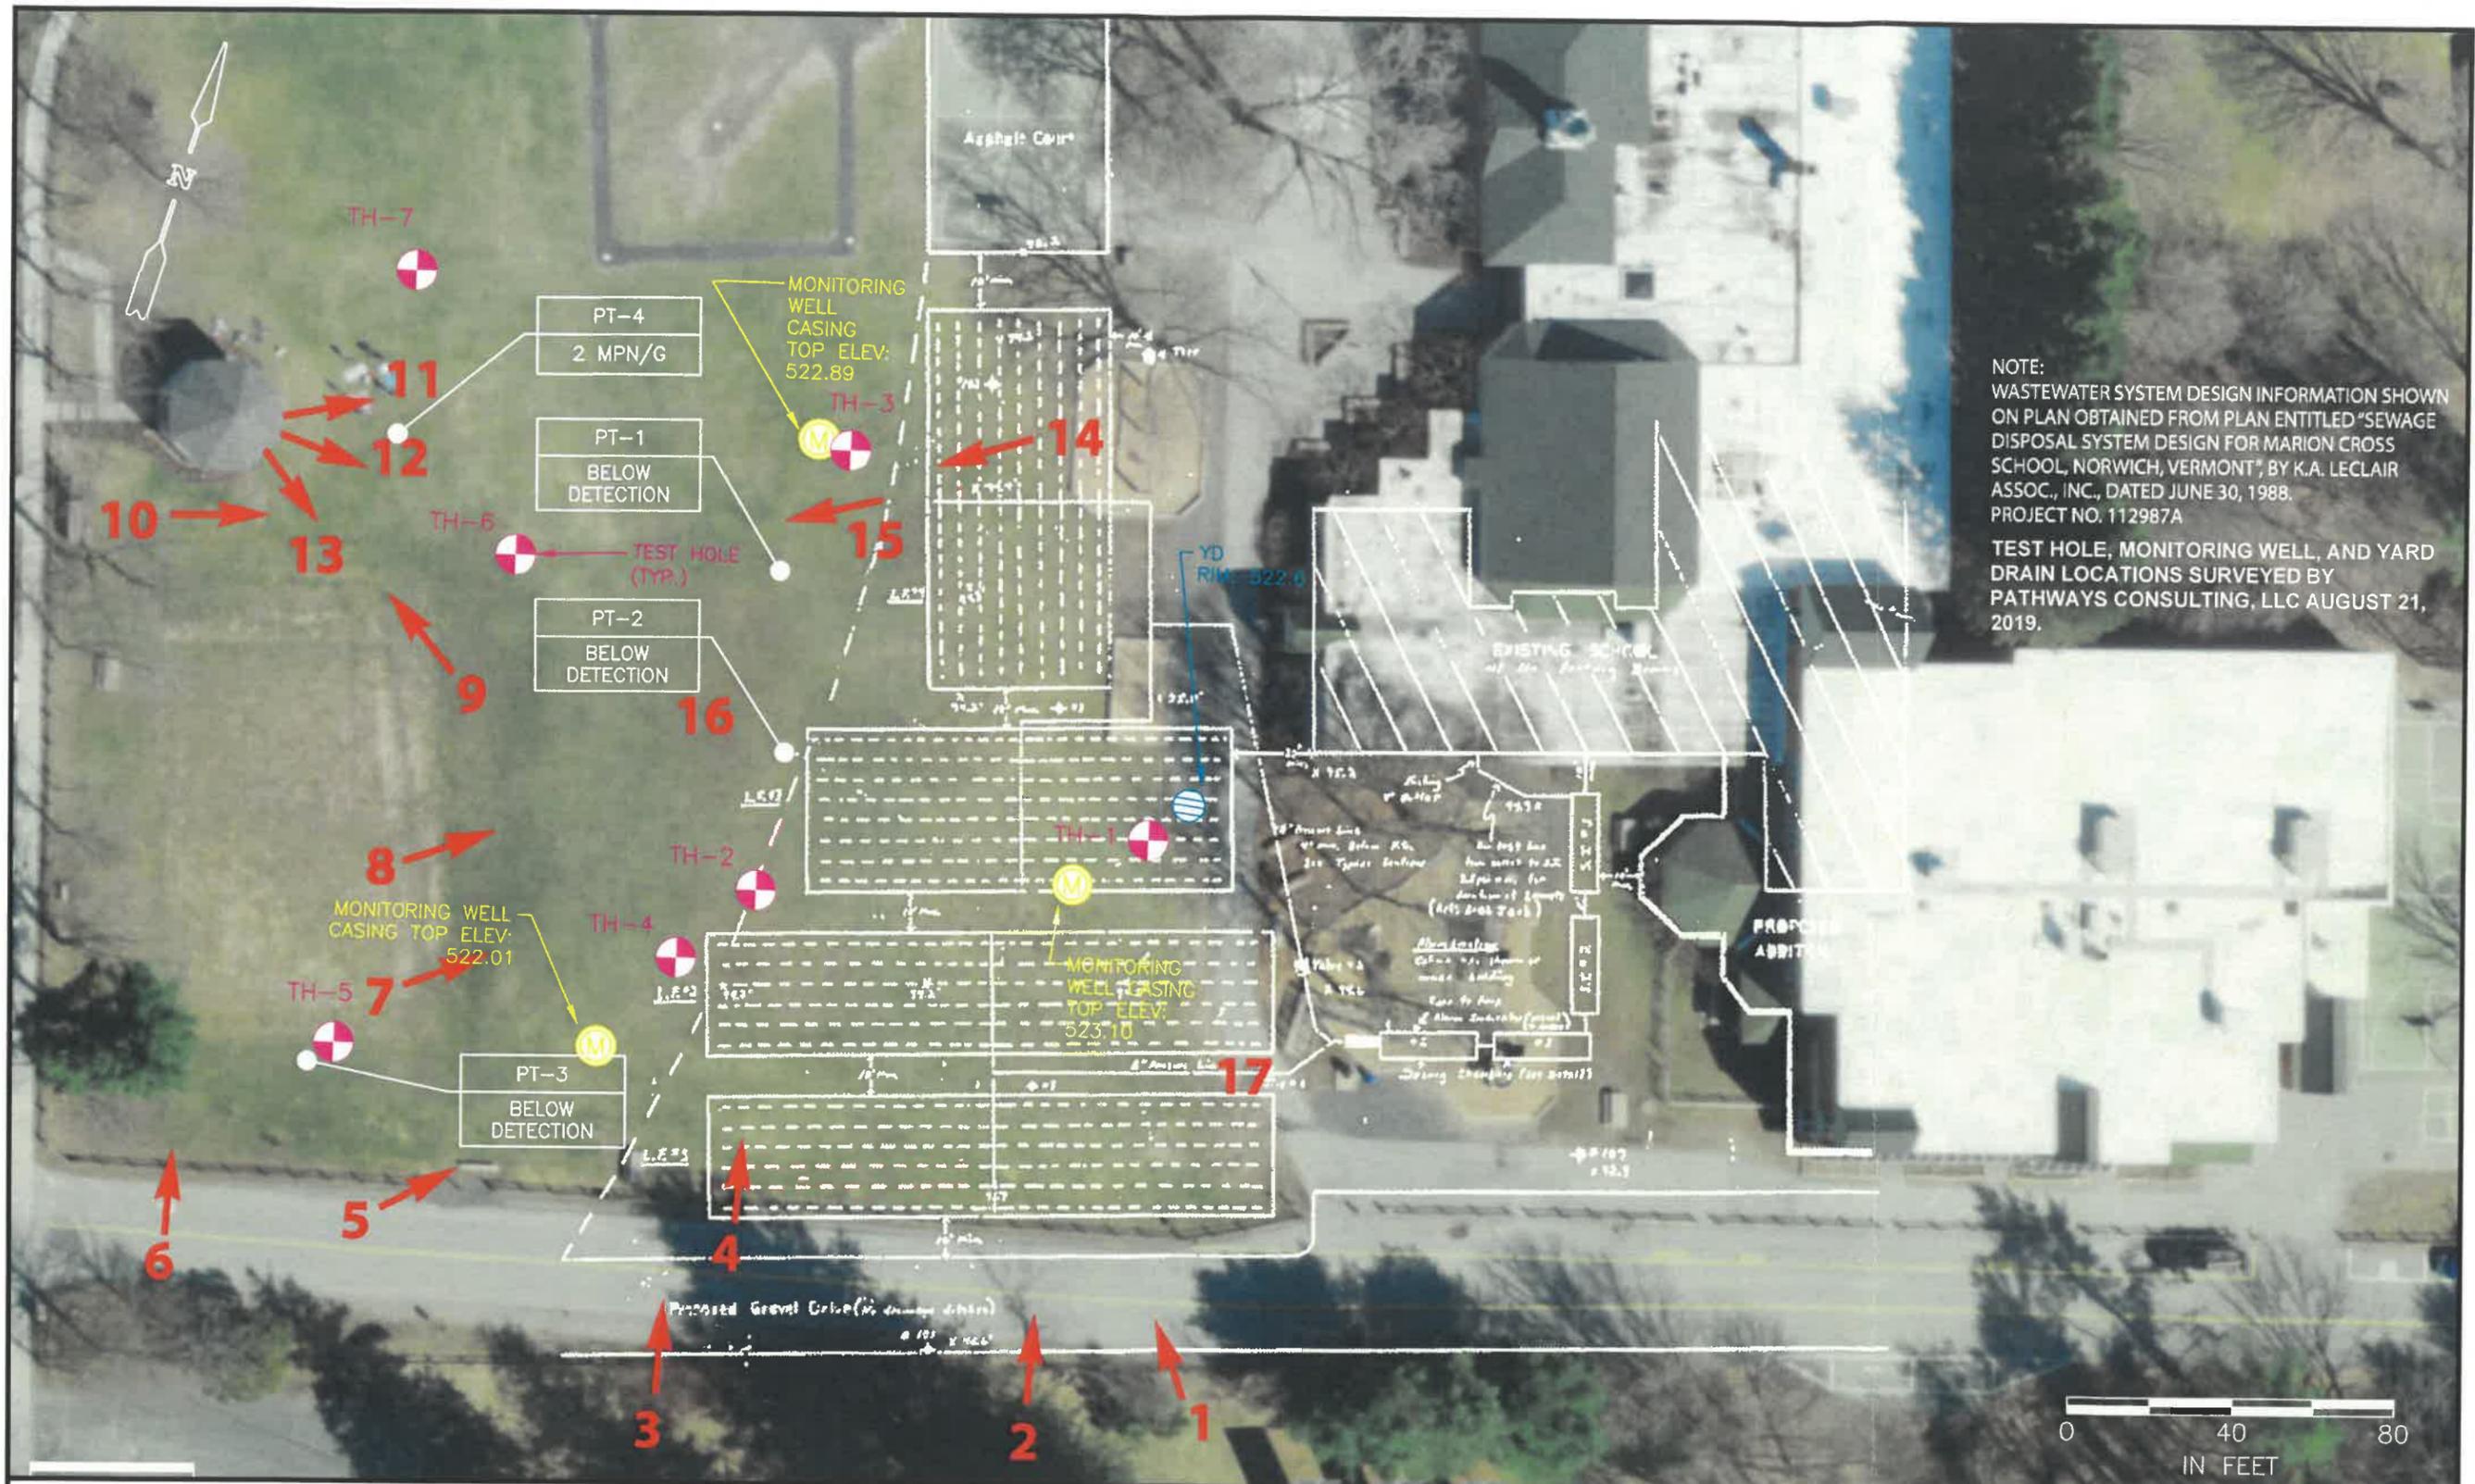
FIGURE
1

Please find enclosed the monitoring data from wastewater sampling that I conducted at the Marion Cross School on January 29, 2018 at the approximate four locations shown on Figure 1, which is attached. Figure 1 also presents January 26, 2018 approximate photo locations on the attached photo log. Endyne Inc., located in Lebanon, New Hampshire, analyzed the samples.

SAMPLING DIAGRAM FOR
MARION CROSS SCHOOL
 ROUTE 5 - NORWICH, VERMONT

Sampling point PT- 4 tested positive for fecal coliform bacteria by the multiple tube fermentation technique (SM20 9221E) at a concentration of 2 MPN/g, which is a concentration level at the lowest laboratory detection limit. MPN, or Most Probable Number, is a quantification of bacterial density in a sample and is representative of a bacteria colony. In other words, the mixture of soil and ice sampled at PT-4 had the potential to harbor two fecal coliform colonies per gram of ice/soil mixture.

Sampling points PT-1 and PT-2 were taken from the presumed location of the leachfields, and what appeared to me to be the most heavily contaminated area of the playground. PT-1 and PT-2 sampling locations required significant ice chipping in order to collect surface water samples. These samples were negative for fecal coliform bacteria.

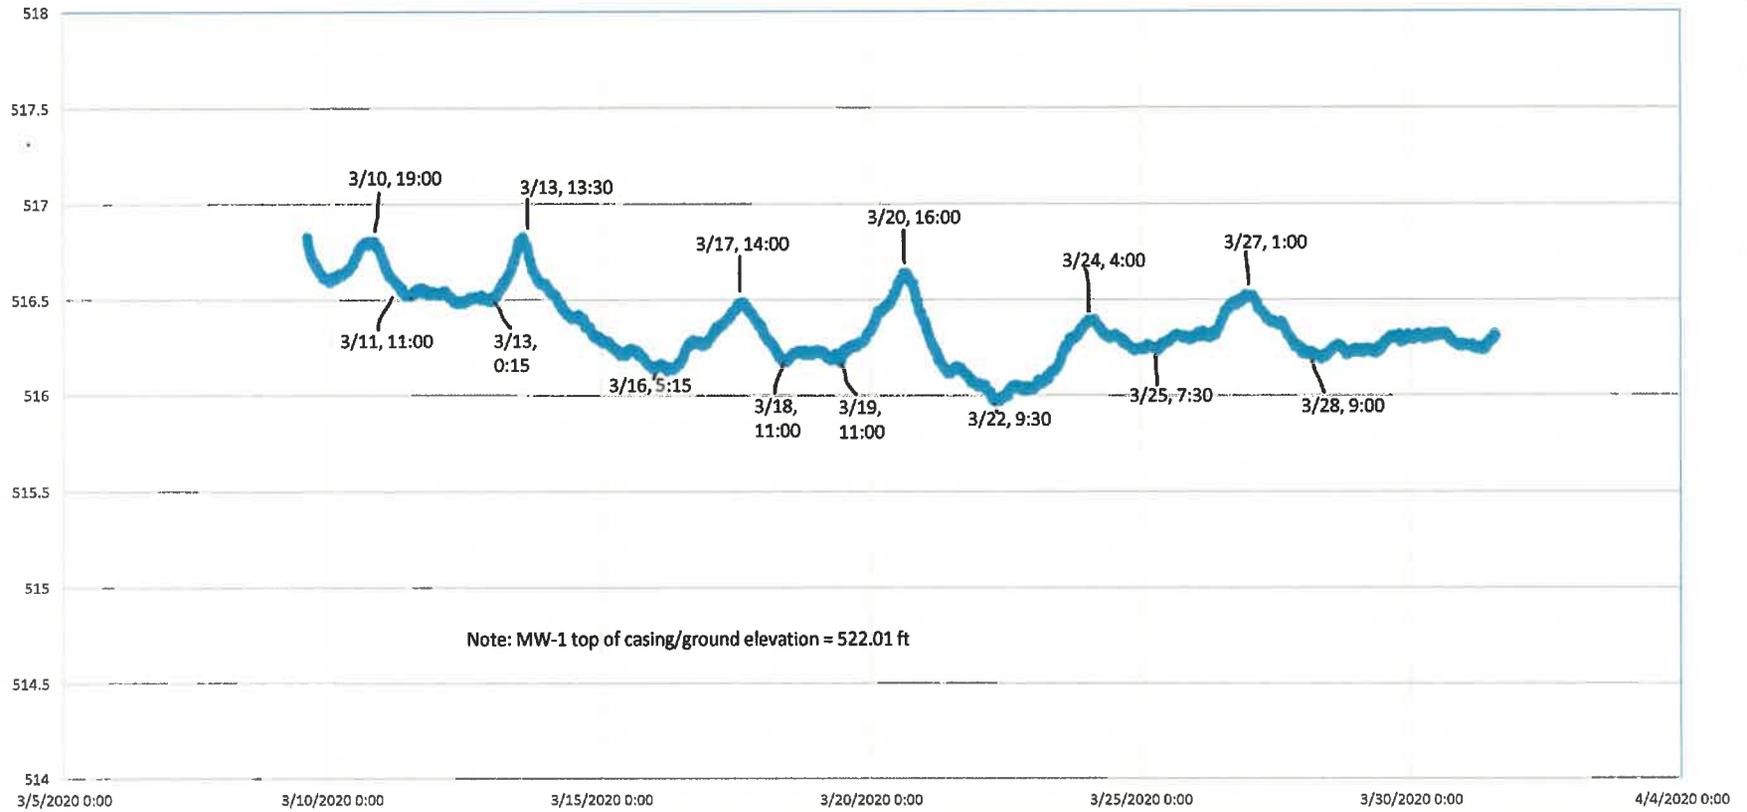
Figure 1. Marion Cross School, MW-1, March 9 - 31 Water Elevation (ft)
(Driveway Side of System)

The graphical results of groundwater monitoring are presented in Attachment E as Figures 1 through 6. A water table data set was collected when the transducers were removed in order to define the groundwater flow direction and the groundwater gradient. To the greatest degree, they were the same as that shown on the Figure 1 Existing Conditions Wastewater Plan, with groundwater flow to the south at a gradient of 0.0068 feet/feet. Monitoring Figure 1 and 3 describe groundwater conditions between March 9 and March 31 in MW-1 (located on the Girard Way side of the disposal area) and MW-2 (located on the ballfield side of the system). The peaks represent system pumping events with the school in operation during the first week and without the school in operation during the remaining period although normal maintenance was being conducted and possibly staff related activities were being conducted in response to Covid-19. Since the disposal areas were installed at an approximate depth of 2.5', the minimum separation of the groundwater system from the bottom of the disposal areas can be calculated. Relative to MW-1, the minimum calculated separation was 3.71'. For MW-3, the minimum separation was 3.54'. The required minimum separation from the groundwater system is 3'. The monitored separation is concerning given only one week of the school operating and the fact that the seasonally high groundwater period had not been completely reached.

Monitoring Figures 2 and 4 describe groundwater conditions between March 9 and March 14 when the school was in operation. These graphs (Monitoring Figures 2 and 4) show nothing different than Monitoring Figures 1 and 3, they just allow a focus on the groundwater conditions when the school was operating. Based on the fact that the monitoring was conducted just after frost left the ground and now the school is no longer operating, the monitoring was suspended because the necessary data was already collected and the collection of additional data would not show anything more that would aid the evaluation.

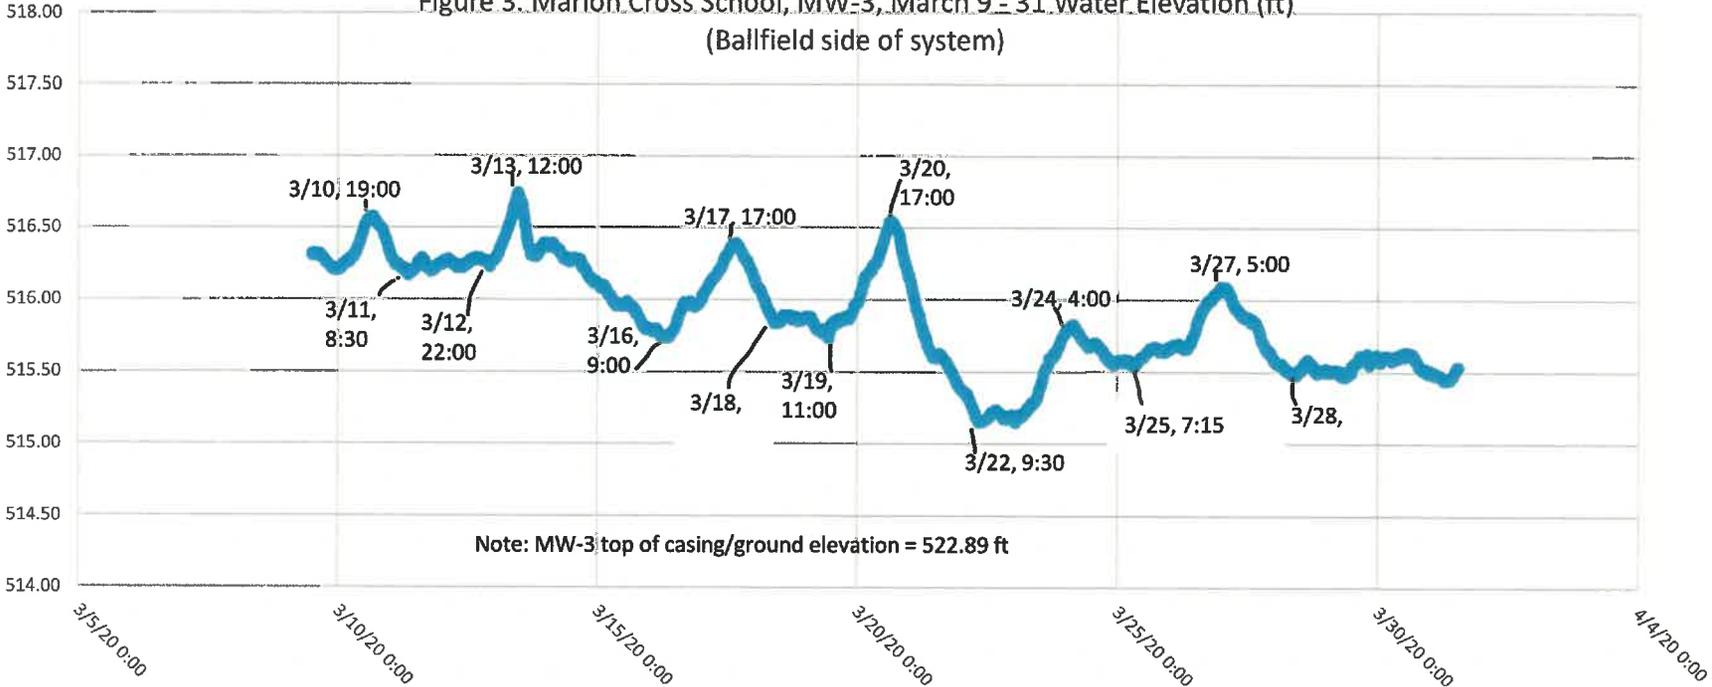
Figure 3. Marion Cross School, MW-3, March 9 - 31 Water Elevation (ft)
(Ballfield side of system)

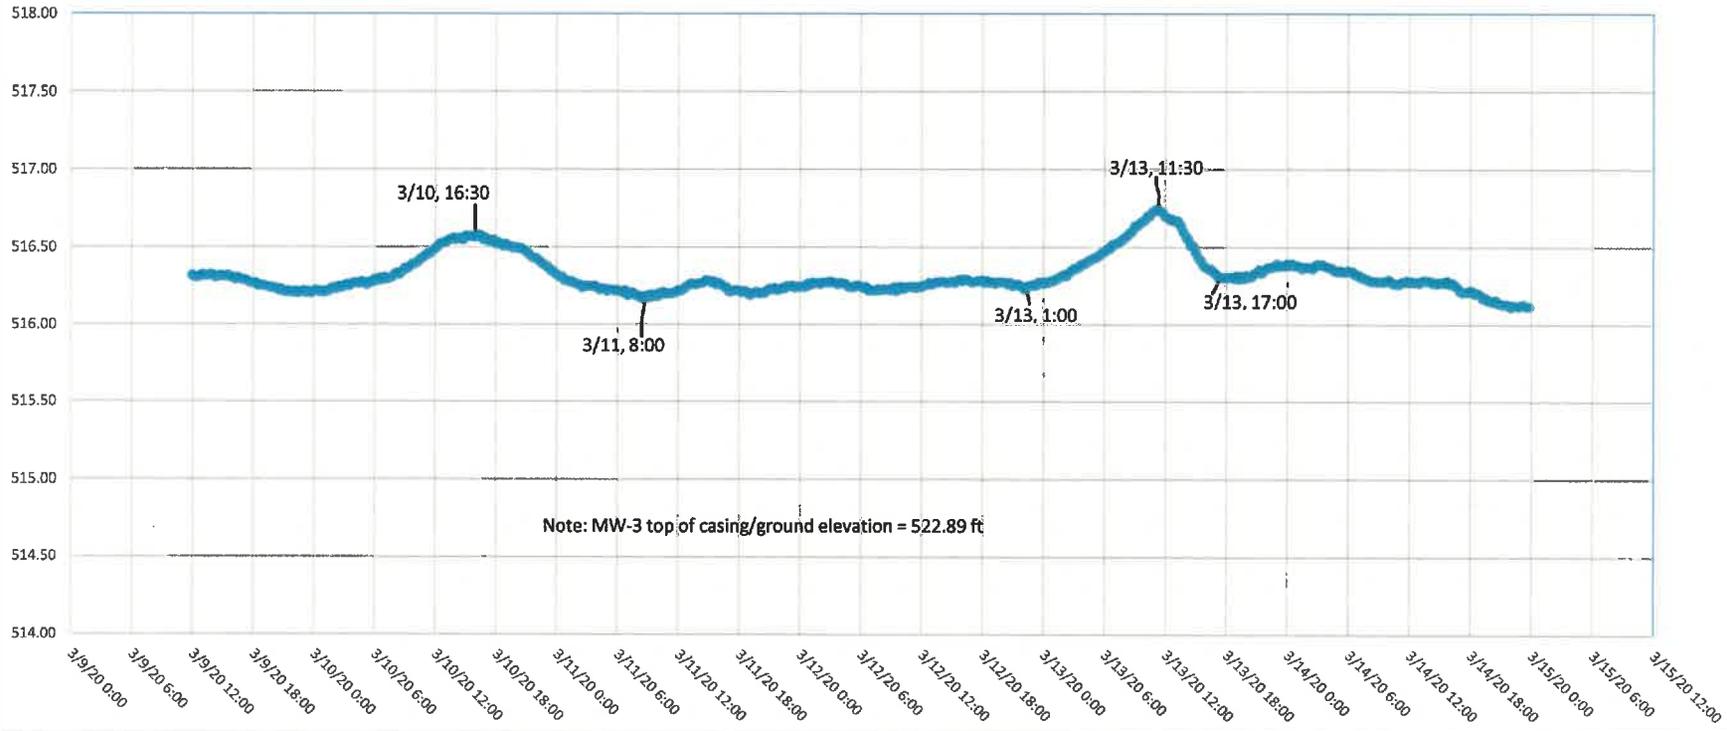
Figure 4. Marion Cross School, MW-3, March 9-14 Water Elevation (ft)
(Ballfield side of system)
